# THE DETECTION AND TRACKING OF STACK EFFLUENT WITH A FORWARD LOOKING INFRARED IMAGING SENSOR

NSWC/DL TECHNICAL REPORT TR-3313

#### ABSTRACT

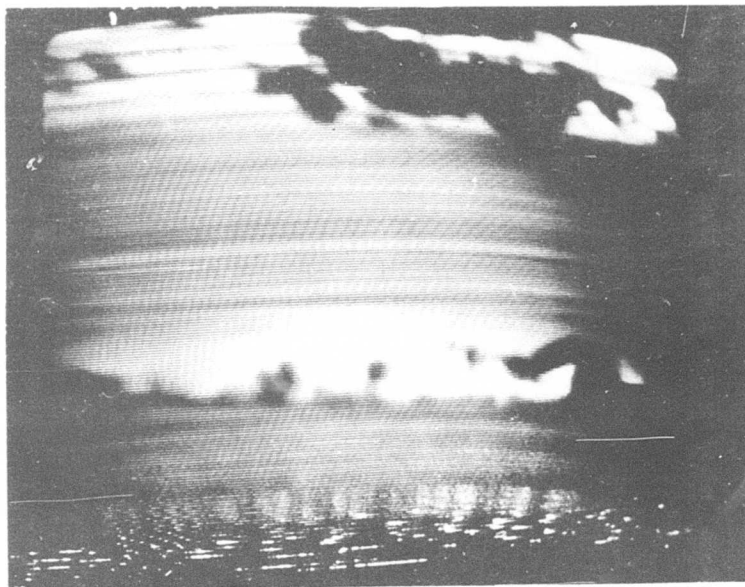
Figure 10. FLIR Imagery from 2.9/3.7 of Plume  
in Aerodynamic Downwash

3. The test on 28 January 1975 was conducted during a period when the spray dryer plume was subjected to aerodynamic downwash (D stability and surface winds greater than 10 mph). Figures 10 through 12 show typical FLIR imagery from this condition. The plume was non-uniformly dispersed by the high gusty winds and slammed toward the ground. The FLIR and mobile sampler recorded the same grid position for this test. Figure 10 shows FLIR imagery from grid site 2.9/3.7 of the plume being bent over. (Note the high apparent temperature of the low clouds above the plume--black = hot on the photographs.) Figure 11 is a FLIR image from grid point 3.7/1.4 with the FLIR in its narrow FOV. The figure clearly shows the plume being torn apart by the gusty wind, which is blowing directly toward the FLIR unit. Figure 12 shows the image from site 3.7/1.4 in wide FOV. The plume is bent over, with a small tuft just below the main body of the plume. The arrow is pointed at the mobile sampler.
